# Church, Saint-Florentin, Burgundy, France

## Damaged Historical Monument Monitoring

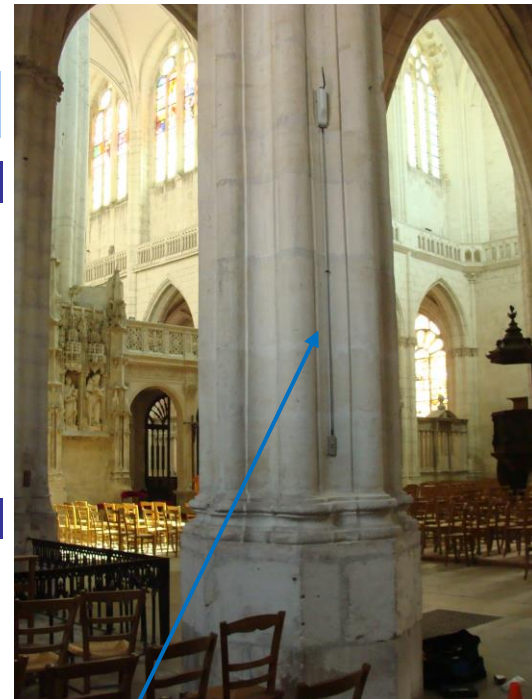
LIRIS Optical Strand on a nave pillar, before protection

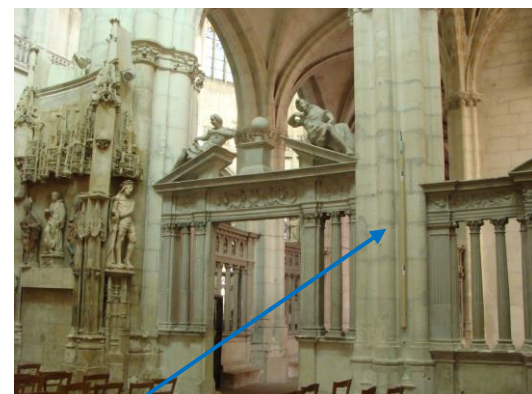
LIRIS Optical Strand on a nave pillar, after protection
