# Bridge over the Rhône River, Seyssel (01)

## Safety availability of a damaged road bridge

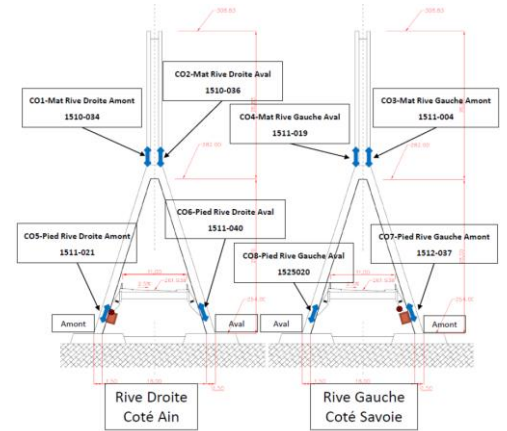
Location of Optical Strands on the bridge pylon

The Optical Strands are positioned vertically on both legs of the pylon on the 2 faces (4 units), and the upper part on the 2 faces (4 units).

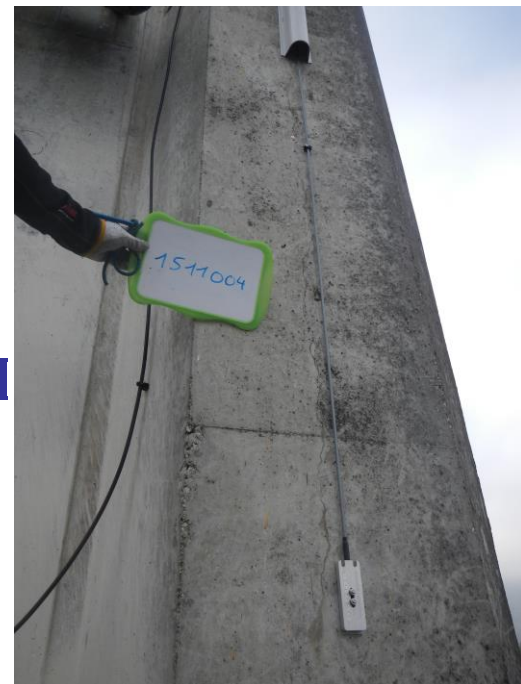
Optical Strand on the pylon upper part

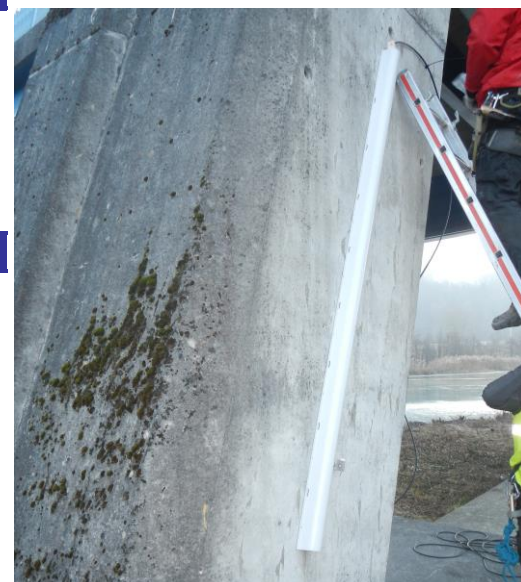
The pylon shows some signs of aging, especially vertical cracks on its both legs. The cause and evolution are unknown.

Optical Strand on a pylon leg
