# Austerlitz Viaduct, Paris

## Log Health Book of a transportation works

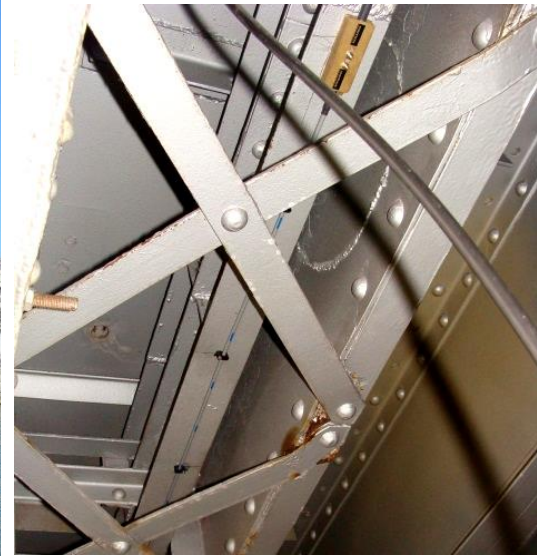
Optical Strand on a braking rod, on the upstream side

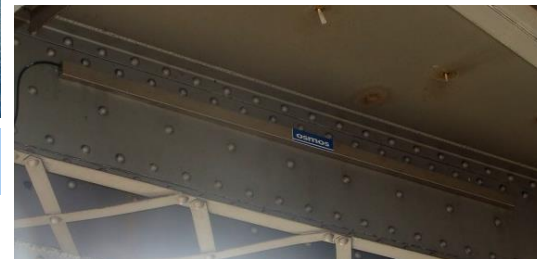
Optical Strand on the upstream anchoring beam, with cover protection

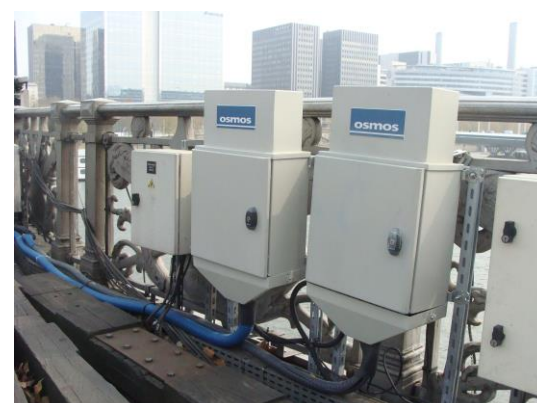
Monitoring Station installed on the Viaduct, near the Austerlitz Station
